Assessment of quality of water from catchment to consumers: A study based on Rahas-Ella water purification plant in Kandy, Sri Lanka

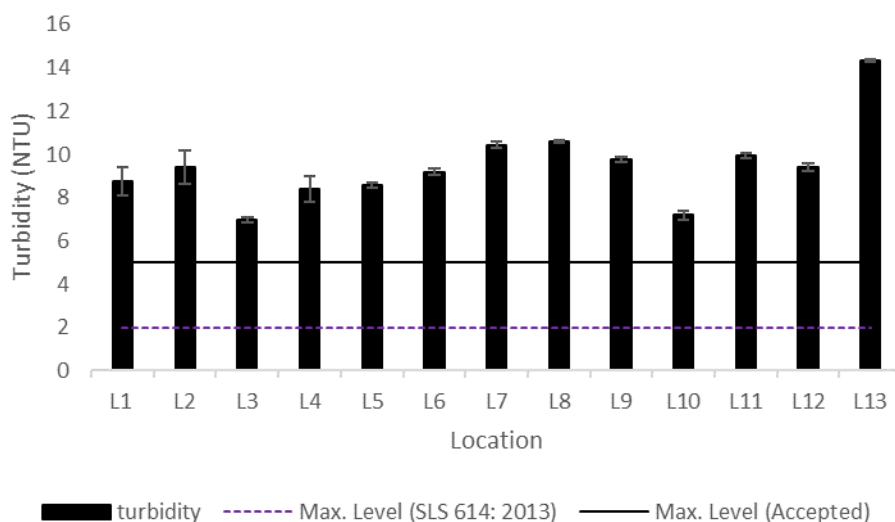
Figure 2. Turbidity of water samples collected from the locations L01 to L13

One of the most important factors in determining the quality of water is turbidity, which is the cloudiness of water brought by various particles. The findings of the turbidity of water samples collected from locations L01 to L13 are shown in Figure 2. The maximum permissible level of turbidity (accepted) should be 5 NTU, while the maximum permissible level of turbidity (Drinking water) should be 2 NTU (SLS614:2013). No health-based guideline value has been proposed for turbidity by the WHO. However, the turbidity readings of the water samples taken from all thirteen locations ranged from 8 to 14.5 NTU, and all of the values were above the accepted and permissible limits.

The water sample from sampling point L01 had a substantial amount of turbidity and contained algae. A significant growth of algae was seen in the sampling location L02 as well. The water from L03 and L04 was also turbid and strongly colored due to the presence of silt. Turbidity at sample point L06 and the rest (L06-L13) was much too high to be used as drinking water, with an average of 9.18 NTU. The average amount of turbidity in the water that was released from the purification plant to the consumers (L09) was 9.75 NTU, which was well above the recommended level. This result showed that the current treatment plant is unable to efficiently handle excessive turbidity of water. The shallow well L13 has a turbidity rating of 14.5 NTU,

which is unusually high. The well is exposed to the runoff from the paddy field that it shares a boundary with. There is a high probability that agricultural fertilizers will leak nutrients. However, it makes sense to assume that silt and enhanced algal growth are the main causes of excessive turbidity of L13.

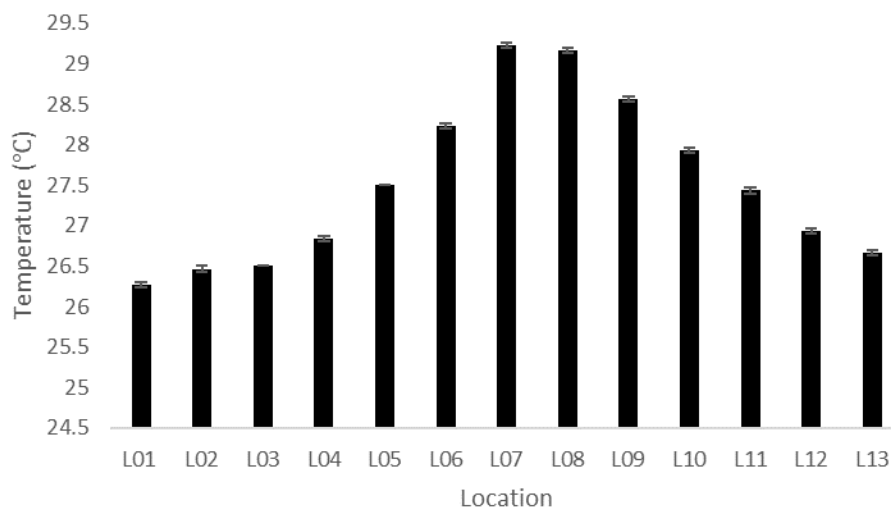
Figure 3. Temperature variations of water samples collected from the locations L01 to L13

Drinking water temperature can significantly increase or decrease during the purification process and through the distribution system to the consumer. However, according to the data, the temperature of the water samples from all sampling points was within the range of 26 °C to 30 °C and was therefore all above the WHO standard of 25 °C. These results imply that all samples had temperatures that were suitable for the development of a wide variety of algae, cyanobacteria, and other microorganisms as particles in water. The presence of particles increases the turbidity of water. Turbidity is a measure of water clarity and high turbidity increases water temperature due to such particles absorbing sunlight. It was found that the turbidity of water samples showed a considerable consistency trend with the temperature of the water detected at the locations (Fig. 3).

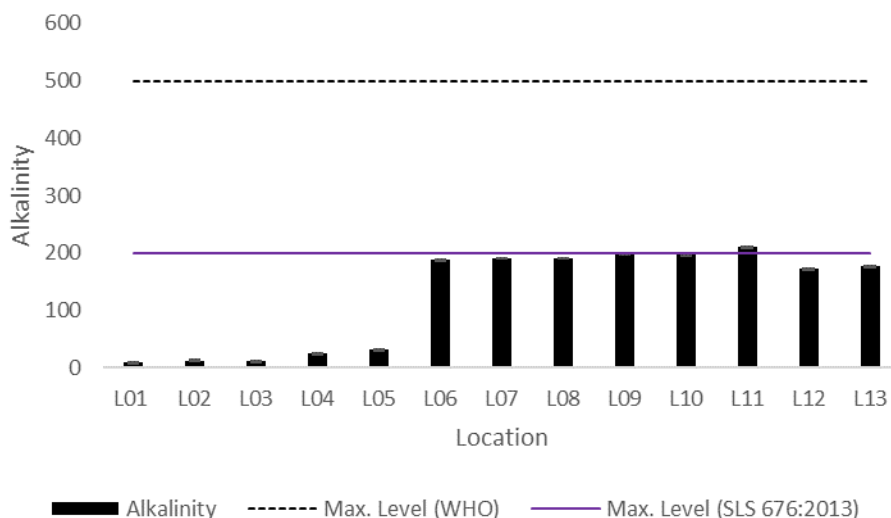
Figure 4 - Alkalinity of water samples collected from the locations L01 to L13

Low levels of alkalinity were found in the water at sample stations L01 to L05, and a significant rise in alkalinity was found at L06. (Fig. 4) This high alkalinity level was maintained throughout the purification procedure and even slightly increased after chlorine was added to the water. The alkalinity of the samples taken from wells was somewhat decreased.

Alkalinity refers to the ability of the water to neutralize acids. Most of the water treatment processes reduce the alkalinity of raw water. However, in this study, samples of water from the intake and up to the filtered water sent through the pipelines to consumers had high alkalinity. Alkaline water generally contains a higher amount of total dissolved solids (TDS) which affects the pH levels of the water. The samples that had lower TDS values showed a pH less than 7 and were slightly acidic.

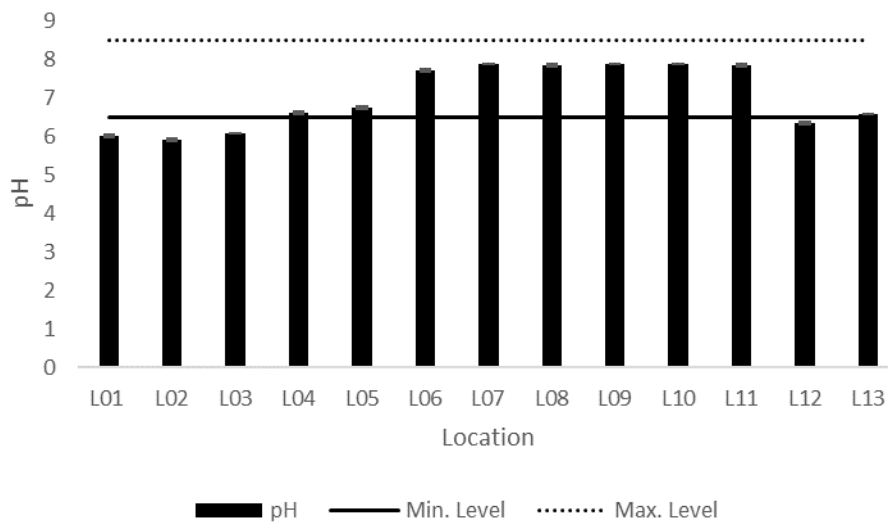
Figure 5 - Variation in pH of the water samples collected from the locations L01 to L13

WHO (2011) and SLS (614:2013), the acceptable and safe pH range of drinking water is 6.5-8.5. The pH values of the collected water samples are found to be within the range between 5.9 and 7.9. Out of thirteen, seven collection points had a pH lower than the neutrality. However, the samples taken from points L06 to L11 and L08, showed a pH higher than 7 and the pH observed from the samples collected at various stages of the purification process and the purified water distributed through the taps (L06 to L11) yielded the maximum pH of between 7.5 and 8.0. However, the pH value of the water distributed to the consumers did not exceed the standard limits (Fig. 5).

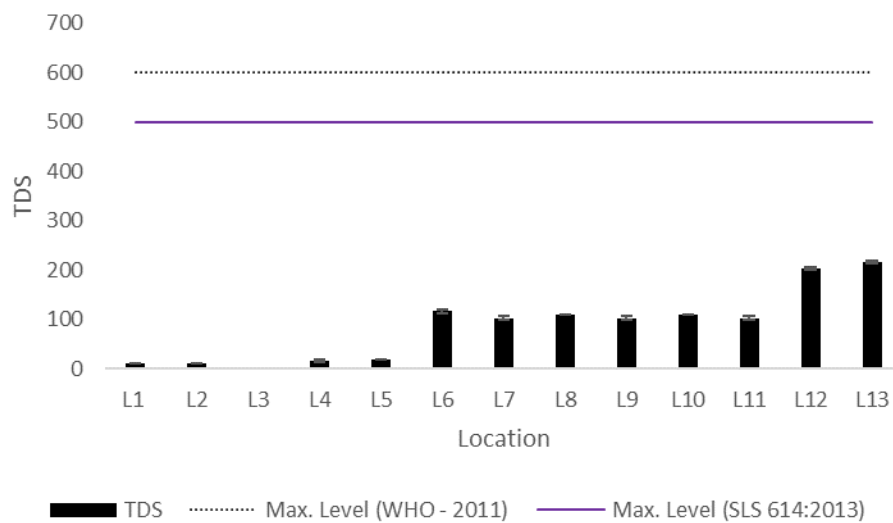
Figure 6 - Variation in total dissolved solids of the water samples collected from the locations L01 to L13

The findings of this study demonstrate that the samples taken from the top portion of the canal (L01- L05) had low TDS values, however, location 6 had a greater TDS value and stayed more or less constant for the samples taken from L06 to L11 (Fig. 6). The sample collected from the shallow well (L13), which was next to a paddy field, had the greatest TDS value, while the deep well (L12), which was in a residential neighborhood, also had a significantly higher TDS value. However, none of the examined samples had TDS levels that exceeded the WHO limit of 600 mg/L water.

The catchment (L06) is subject to several human activities, and the TDS seemed to rise as the treatment operations progressed. As a result, the TDS level increased slightly after sampling

point L06 but remained steady. The samples taken from the wells (L12 and L13) had greater TDS levels, which may have been caused by organic compounds and other ions dissolved in the well water.

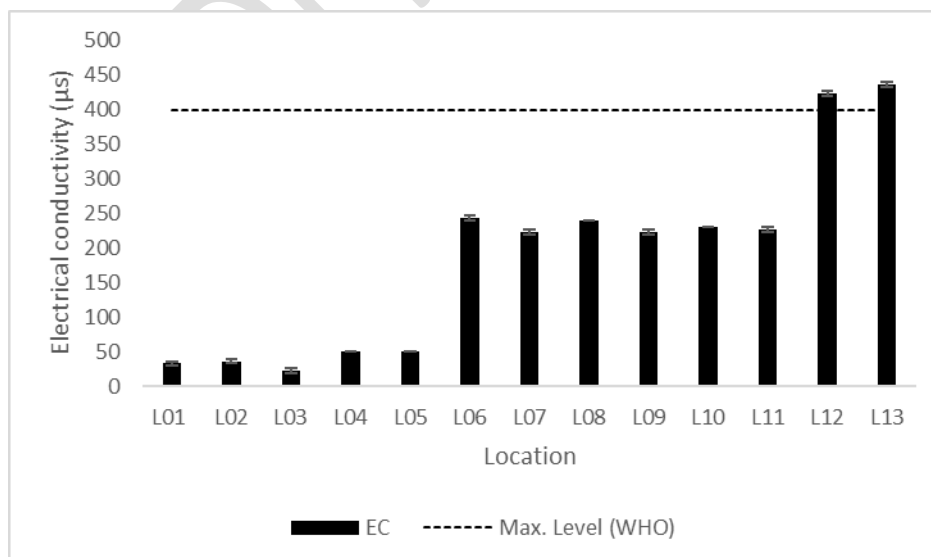
Figure 7 – Electrical conductivity of the water samples collected from the locations L01 to L13

According to the WHO guidelines, the electrical conductivity of drinking water should not exceed 400 $\mu\text{S}/\text{cm}$. This present investigation indicated that the EC value was 30 – 450 $\mu\text{S}/\text{cm}$ with an average of 188 $\mu\text{S}/\text{cm}$ (Fig. 6). The samples taken from L06 to L11 revealed greater EC values, but they were more or less steady for all six samples and none of them exceeded the maximum value, quite similar to the TDS values.

The relationship between TDS and EC is a function of the type and nature of the dissolved cations and anions in the water. The two samples taken from wells had considerably higher TDS as well as EC values and the EC values exceeded the maximum level, as shown in Fig.7. The surface water that percolates into the ground due to gravity and the spring water passes through the soil might dissolve materials in the rocks and soil they come into contact with and this could explain why tested well water samples had higher EC values.
