RURAL KITCHEN DESIGN - A CASE STUDY

Abstract: Kitchen is the heart of a house. Since major part of time is spent in kitchen compared to other areas in the house, it needs to be designed with utmost care. Attention needs to be paid to the type of kitchen, work areas in kitchen i.e., preparation area, sink and cooking area. Storage facilities, openings and ventilation must be adequate so that home maker can do cooking with less strain. With this background, the present study has been conducted through case study method to evaluate the kitchen design in rural areas. The study was conducted in Dabliguda, Maheswaram Mandal in Telangana state. Observations were made in 10 kitchens to understand the existing kitchen conditions. It was found that all the kitchens were placed in the right direction i.e., east. Kitchen sizes also met with the standard specifications as minimum size was 90 sq. ft. and maximum size being more than 150 sq. ft. against 45 sq. ft. as the standard size. But the drawbacks observed in the rural kitchens were lack of adequate ventilation, absence of work triangle as only two working spaces are provided in most of the kitchens and very deep storage shelves. The study

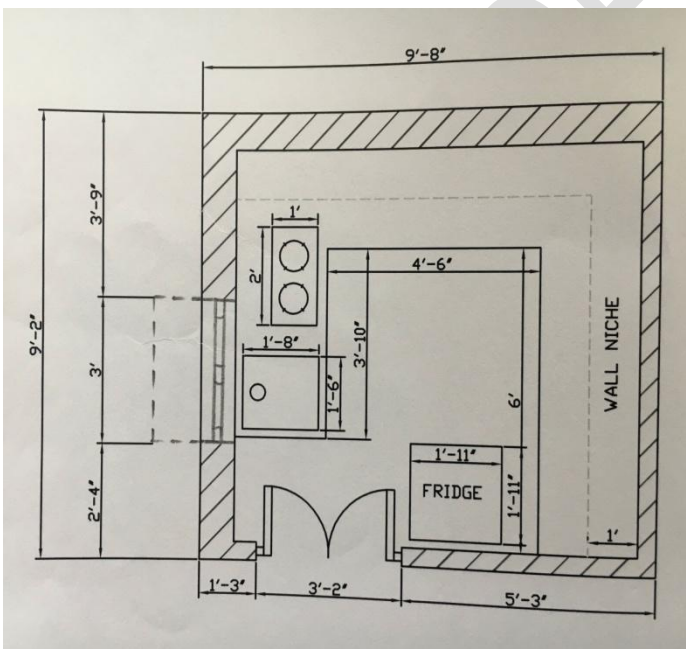
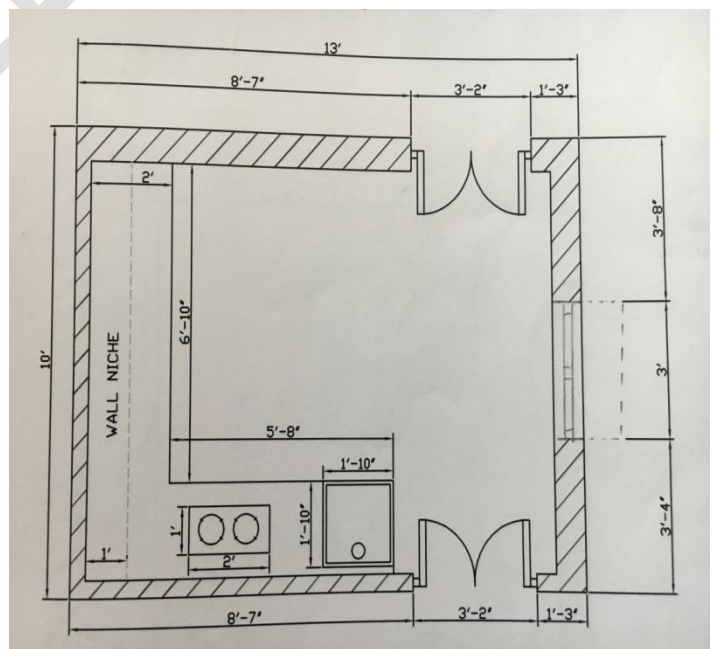
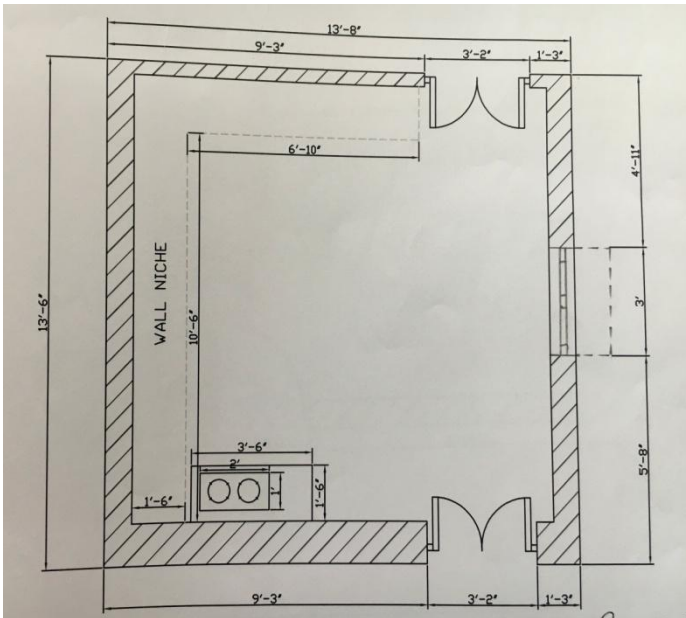
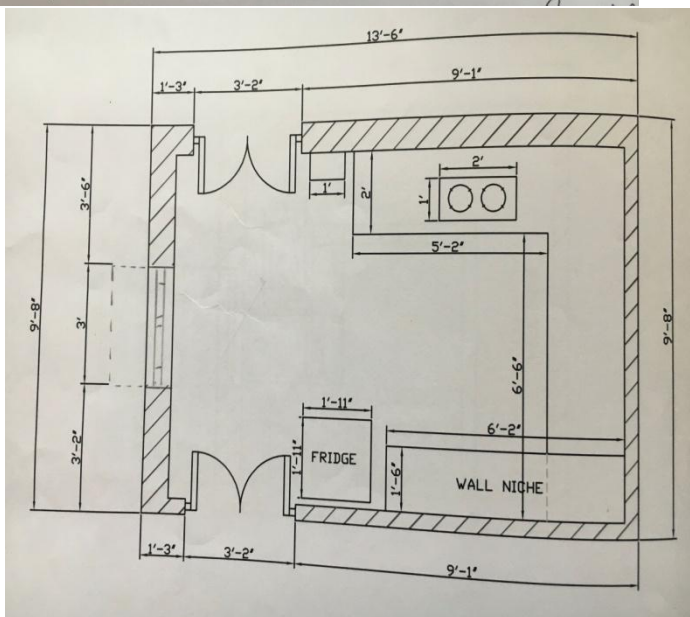
Figures 1 – 4: Floors plans of the Kitchens surveyed

- (f) **Type of Kitchen:** Two types of kitchens were found in the surveyed households i.e., L shape and U shape kitchens.
- (g) **Appliances and Work triangle:** All the kitchens surveyed had a gas stove. Half of them had a sink and refrigerator. The work triangle is an imaginary triangle formed between the three workspaces in a kitchen: (i) Refrigerator, (2) Sink and (3) Stove. In the case of the surveyed households, the work triangle was not formed in most of the kitchens, as the three workspaces were not present. Only one - third of the kitchens surveyed had a work triangle, but the distance between all the three appliances was not proper as the kitchen size was small.
