Case report – Accidental Epidural Catheter breakage and its management

ABSTRACT:

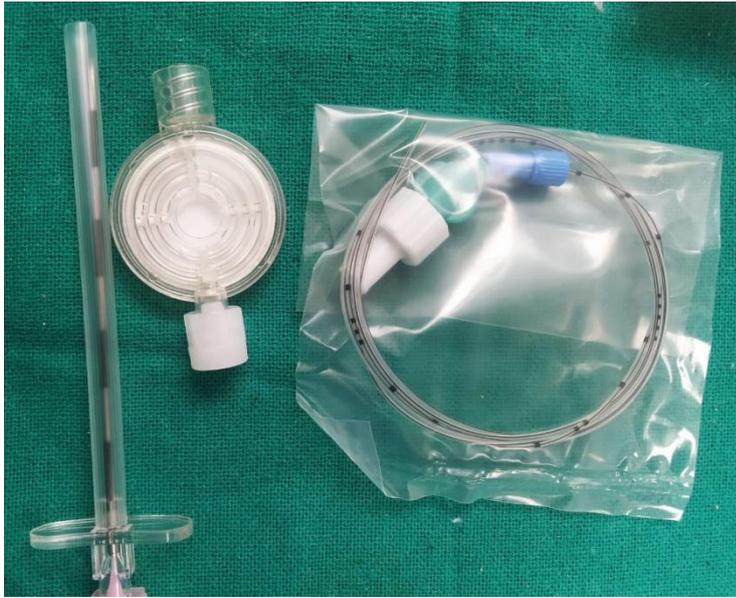
Figure: 1 - MEDITECH Epidural Minipack Set which was used

After confirming nil by mouth status and written informed consent, the patient was taken for surgery. Under all aseptic precautions and local infiltration of skin with 2ml of 2% lignocaine, an 18 gauge, 80 mm Tuohy needle (MEDITECH Epidural Minipack System-Figure:1) was inserted to access the epidural space in L2–L3 intervertebral space with loss of resistance technique in the sitting position. The epidural space was encountered 5 cm from skin through a midline approach, and an 18-gauge close-ended multihole epidural catheter advanced up to 12 cm after which a resistance was felt. Hence, the both catheter and needle were simultaneously removed using minimal force but the catheter sheared off, it was found that the catheter was broken from almost 7 cm mark. Immediately, operating surgeons were informed about the event. Patient and patient's relatives were informed about the incident immediately and counselled about the complications associated with the same.

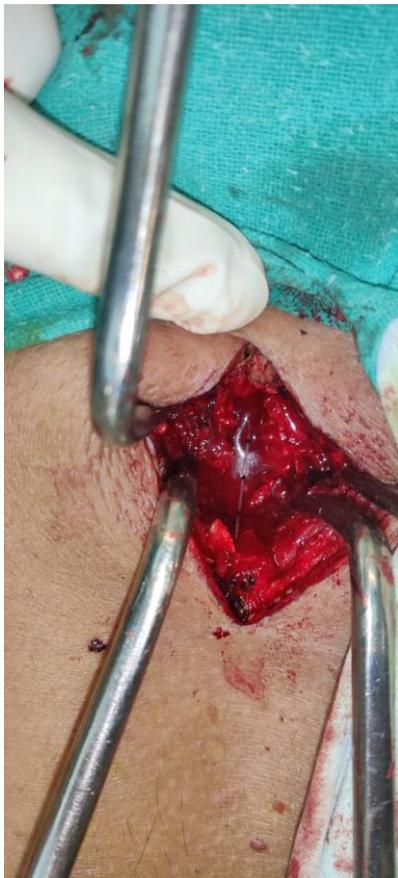
Figure 2:- The broken catheter found during surgical exploration

A exploratory laminectomy under general anesthesia in prone position was planned. 5 cm incision was taken at lumbar(L2-L3 space) . The surgeons gently dissected through layer by layer and a catheter was found lying in paraspinal muscles. A total length of 7 cm of epidural catheter was retrieved (Figure-2).

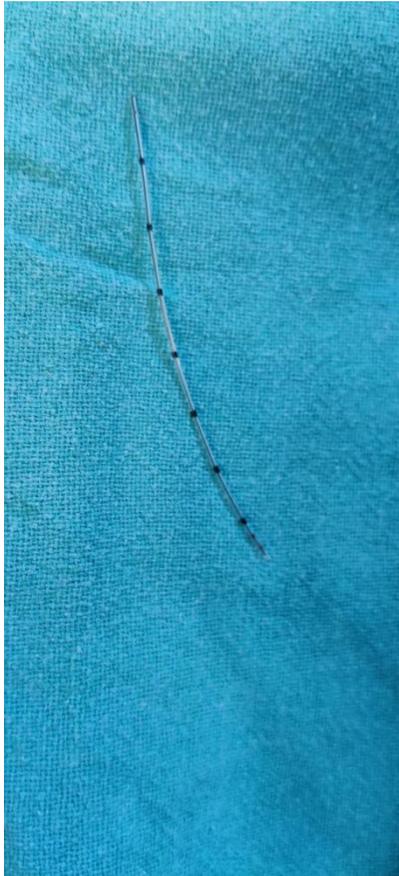
Figure 3 :- Broken epidural catheter retrieved after surgical exploration which is about 7.5cm

Since the part of the catheter which broke was large (almost 7 cm, Figure-3) and may cause complications in future like infection and neurological complications, foreign body removal was planned by spine surgeons immediately after discussing with patient and patient's relative and the whole operating team.
