THE ROLE OF PUBLIC HEALTH AND EARTHQUAKE OCCURRENCES IN MYANMAR (A Case Study: the 2017 Taikkyi Earthquake)

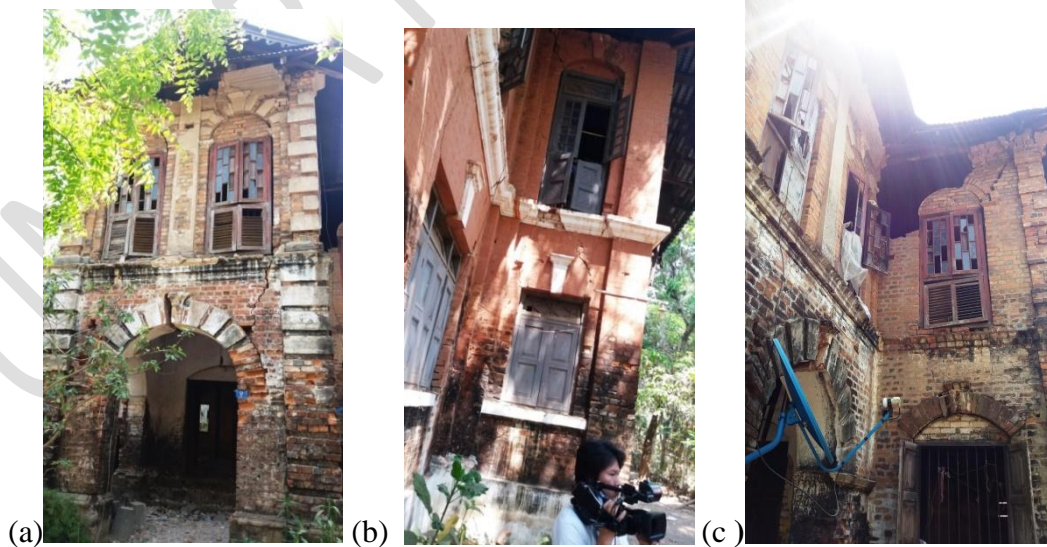
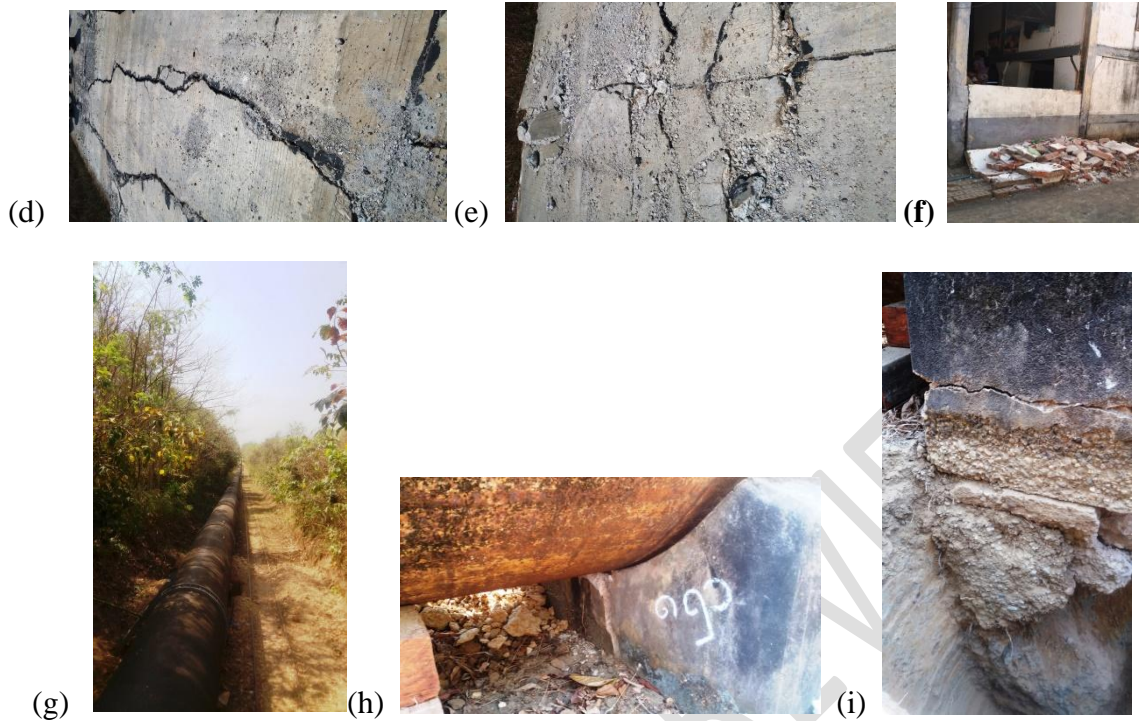
Fig.3.(a,b,c) Photos of damage to a building in which upper floor was fallen to the ground due to Taikkyi earthquake. (e,f) damage to the pavement of the road in Takkyi. (g) Damage to the wall of a building. (g,h,i) Damage at the base of Gyophyu pipeline.

The Taikkyi earthquake spread a wide area including Thayarwaddi, Okkan in the north, TawLaTi, Aphauk in the west, Yangon in the south and surrounding area west of Bago Yoma. The region surveyed was found to have three grades of the Modified Mercalli Intensity scale: VI, VII, VIII based on people's perception, indoor effects, damaged buildings, and ground survey of affected area. A small number of simply constructed houses and aged buildings were collapsed. Upper portion of some pagodas are fallen down. Position of objects in monastery was shifted and brick fences are fallen down. Some portion of water pipe-line from Gyophyu Reservoir to Yangon has been uplifted and shifted. It is due to that the ground motion was strong enough to fling up the ground as the fault rupture beneath it. The overall width of the pavement was reduced and shortened. People of Taikkyi strongly and distinctly felt the quake. Local people are interviewed for a felt report of ground deformation during Taikkyi earthquake. Villagers explained that the main shock was very powerful and they felt like their houses were hit by an elephant with great fury. Intensity (MMI VII) was reached in the town Taikkyi where the shaking was severe. Isoseimals followed the trace of the Taikyi fault in elongated pattern of NNW-SSE direction. Aftershock activity of the Taikky earthquake was distributed over much of Taikkyi area. The seismic activity migrated to the south towards Yangon [1].
