Case study

“Esthetic rehabilitation in maxillary anterior zone in patient with fluorosis and congenitally missing lateral incisors with space closure using laminate veneers-A Case Report”

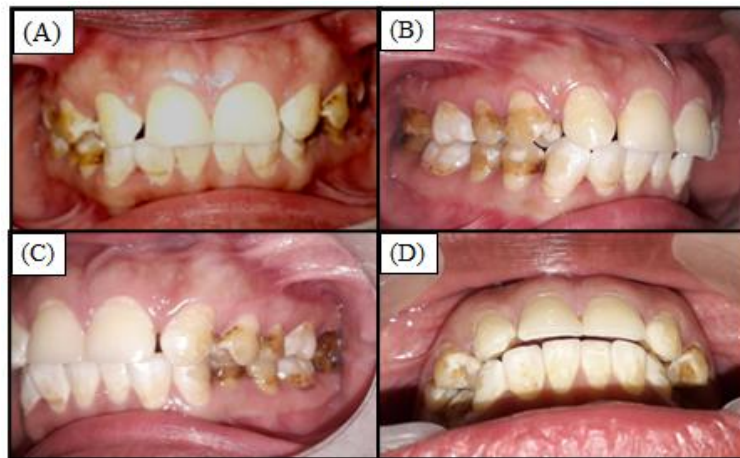
examination revealed missing right and left upper lateral incisors and generalized fluorosis representing as opaque patches, subsurface brown staining and small pits in enamel (Fig. 1)

Figure 1: Preoperative clinical photographs: (A) frontal view, (B) lateral view: left side, and (C) lateral view: right side. (D) intra oral view revealing overjet.

The patient was informed about treatment options, which includes ceramic or composite veneers, along with the advantages and disadvantages of each option. Patient was convinced for eight porcelain laminate veneers from his upper right 2nd premolar to upper left 2nd premolar.

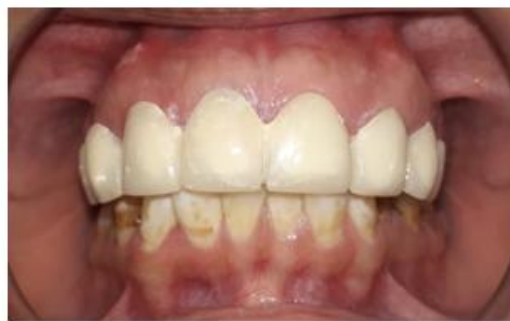
temporization was followed and provisional restoration was polished using burs and polishing discs and cemented using light cured composite (Fig.4).

Figure.4 Temporization

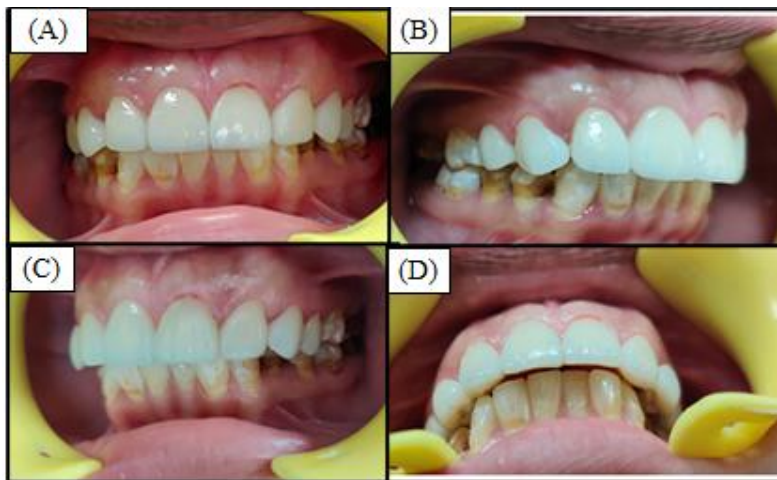
Figure 5. Post operative clinical photographs:(a) frontal view, (b) lateral view: right side, and (c) lateral view: left side (d) intra oral view revealing overjet.

After drying, a dual cured resin cement (Variolink; Ivoclar vivadent) is applied to the inner surface of the laminates and the laminates are positioned and gently pressed on to the teeth. After that, each veneer was light-cured for 30 seconds from facial aspect and 30 seconds from lingual aspect. First two veneers of the central incisors were simultaneously cemented. This was followed by cementation of the veneers of the two canines which were contoured to look like as lateral incisors. Then, first premolar veneers were cemented which were contoured to look like as canines and finally second premolar veneers were cemented. Carbide finishing burs were used to remove excess resin cement at the margins and final finishing was done with polishing cups and points (Fig.5). The patient was happy with the final result of the treatment and post treatment instructions and maintenance protocols were explained to the patient. Follow up was done in every 3 months.
