Case study

“Esthetic rehabilitation in maxillary anterior zone in patient with fluorosis and congenitally missing lateral incisors with space closure using laminate veneers-A Case Report”

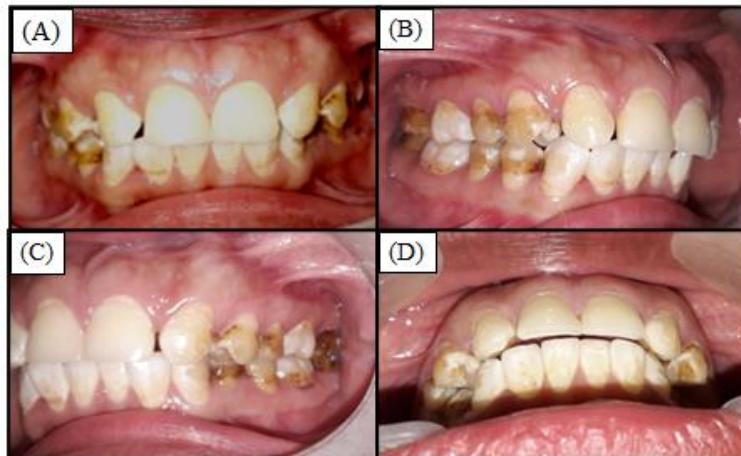
examination revealed missing right and left upper lateral incisors and generalized fluorosis representing as opaque patches, subsurface brown staining and small pits in enamel (Fig. 1)

Figure 1: Preoperative clinical photographs: (A) frontal view, (B) lateral view: right side, and (C) lateral view: left side. (D) intra oral view revealing overjet.

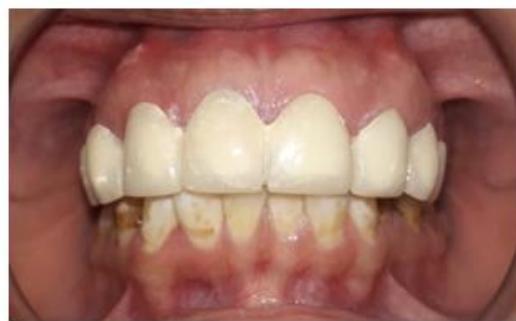
temporization was followed and provisional restoration was polished using burs and polishing discs and cemented using light cured composite (Fig.4).

Figure.4 Temporization

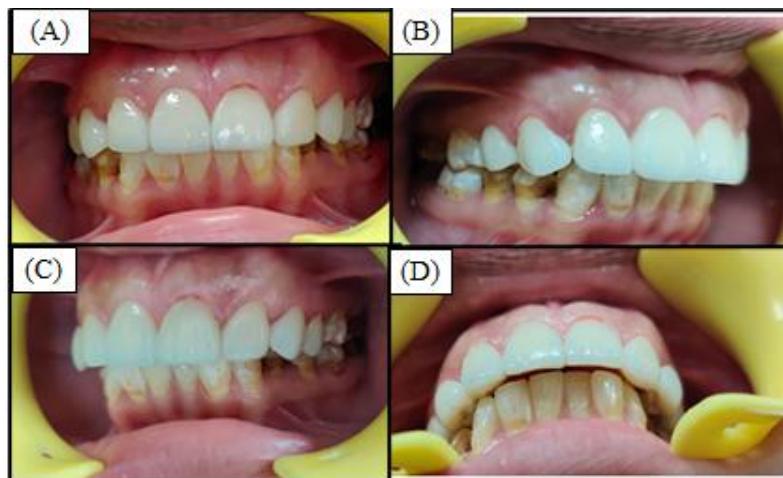
Figure 5. Post operative clinical photographs:(a) frontal view, (b) lateral view: right side, and (c) lateral view: left side (d) intra oral view revealing overjet.

After drying, a dual cured resin cement (Variolink; Ivoclar vivadent) is applied to the inner surface of the laminates and the laminates are positioned and gently pressed on to the teeth. After that, each veneer was light-cured for 30 seconds from facial aspect and 30 seconds from lingual aspect. First two veneers of the central incisors were simultaneously cemented. This was followed by cementation of the veneers of the two canines which were contoured to look like as lateral incisors. Then, first premolar veneers were cemented which were contoured to look like as canines and finally second premolar veneers were cemented. Carbide finishing burs were used to remove excess resin cement at the margins and final finishing was done with polishing cups and points (Fig.5). The patient was happy with the final result of the treatment and post treatment instructions and maintenance protocols were explained to the patient. **Follow up was done in every 3 months.**
