RURAL KITCHEN DESIGN - A CASE STUDY

Keywords: rural, kitchen, design, features, standards

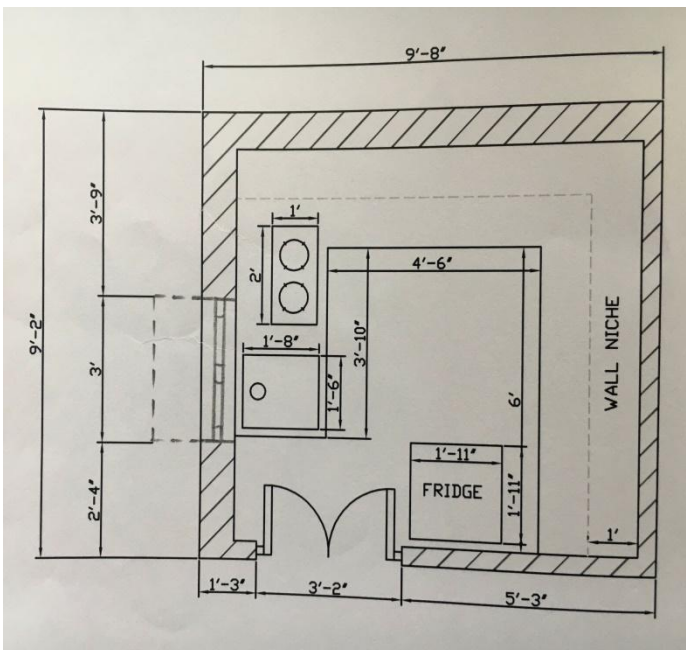
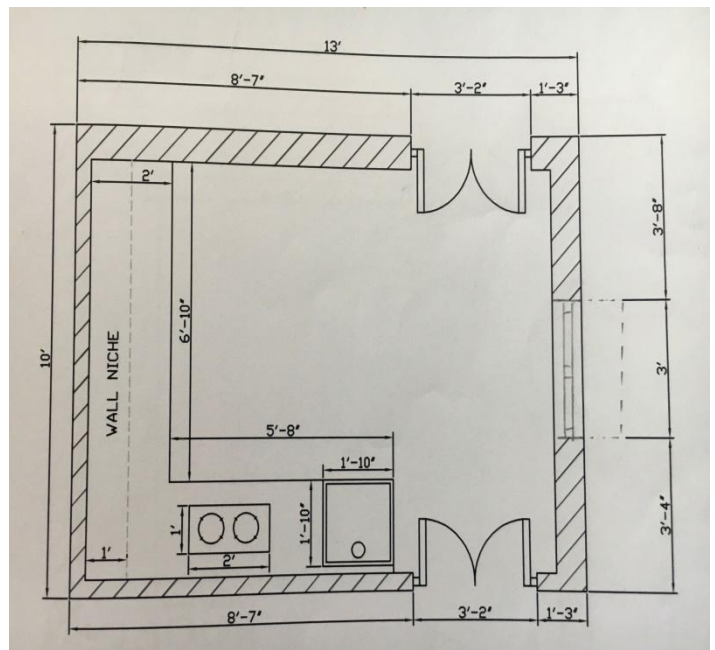
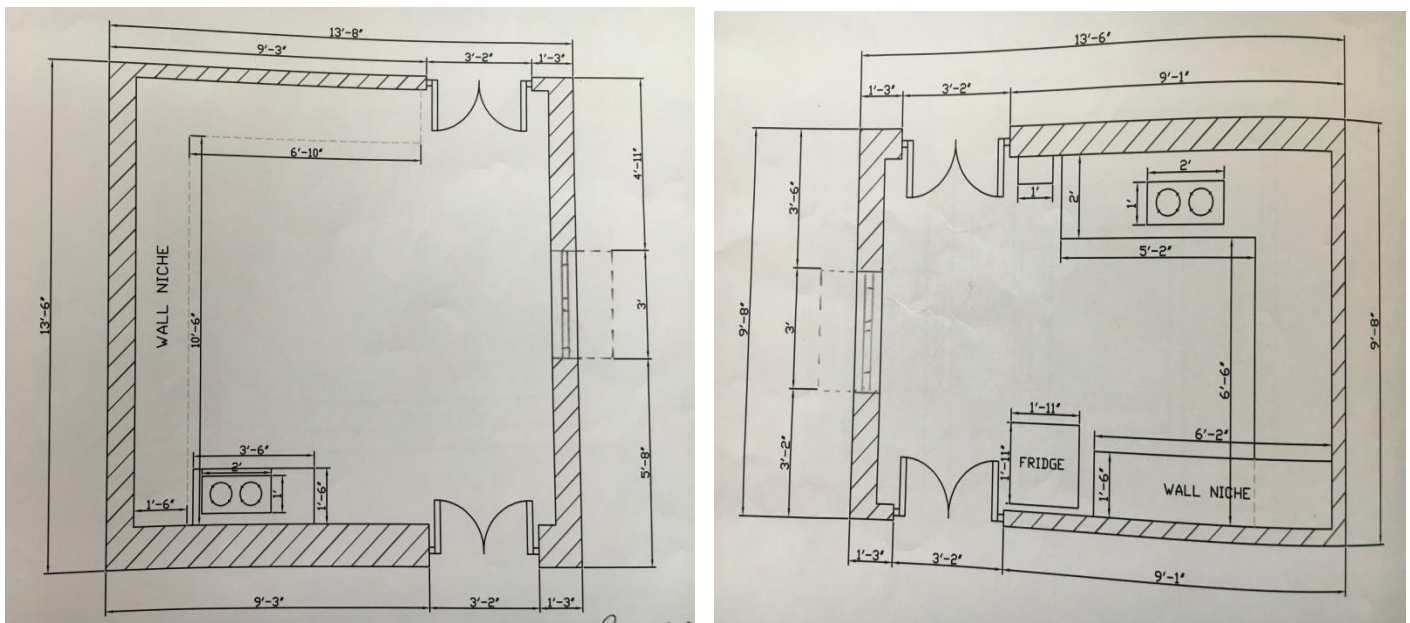
- (e) **Area/ Size of the Kitchen:** Different sizes of kitchens were observed. None of them had a common size like the doors and windows as the space allocated for the kitchen depended on the space available to the owner for building a house. The minimum size of the kitchens observed was found to be nearly 90 sq. ft. and the maximum size was around 188 sq. ft.

- (f) **Type of Kitchen:** Two types of kitchens were found in the surveyed households i.e., L shape and U shape kitchens.
- (g) **Appliances and Work triangle:** All the kitchens surveyed had a gas stove. Half of them had a sink and refrigerator. The work triangle is an imaginary triangle formed between the three workspaces in a kitchen: (i) Refrigerator, (2) Sink and (3) Stove. In the case of the surveyed households, the work triangle was not formed in most of the kitchens, as the three workspaces were not present. Only one - third of the kitchens surveyed had a work triangle, but the distance between all the three appliances was not proper as the kitchen size was small.

Figures 1 – 4: Floors plans of the Kitchens surveyed
