## Method Article

### **Water Harvesting, Land and Water Use Planning for Sustainable Agriculture for the Western Part of the West Bengal**

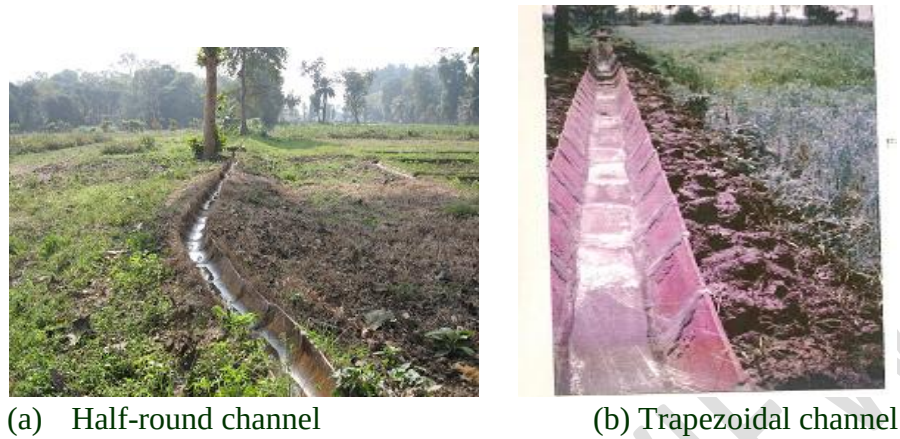
**Fig. 6** Half-round and trapezoidal earthen tile made channels

The amount of available water in the ponds or in the river or canal is being used in conventional way. The conveyance channels are earthen, zig-zag, and poorly managed. It incurs high conveyance and application losses. It can be presumed that more than  $\frac{2}{3}$ <sup>rd</sup> of water diverted from the source not comes in use to the crops. These irrigation channels may be lined. Brick and concrete channels are found popular to the farmers. These are costlier. Instead of these much less costlier earthen tiles may be used to line the irrigation channels (**Fig.6**). The earthen tiles not only less costly but also eco-friendly and can be made by the local potters. It will have positive impact to local economy (Biswas, 2009). The longevity of this channel is high and loss of water

through it decreases with the advancement of time in contrary to the characteristics of other lined channels.

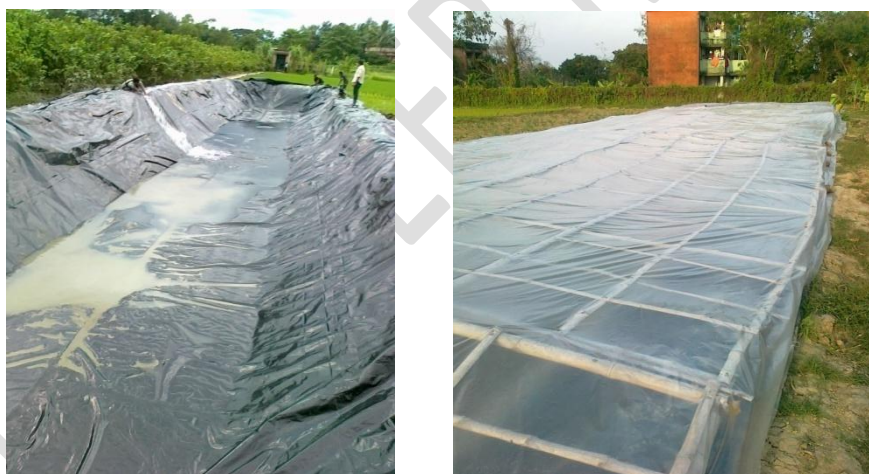
**Fig.13** Rectangular *Jallergola*

For **0.2ha** field, the trench may be excavated by 3m width x 2m depth x 31m length of 2 numbers. The polythene is to be placed along the sides and bottoms of the trenches and anchored properly on the bank as shown in **Fig.13**. The top is covered with polythene attached to bamboo sticks made net. This polythene also anchored properly in soil to stop movement of air over water in trench. However, some portion may be kept open if specialized (air breathing or such type) fish culture is done with supplement feeding.

- i) Excavation =  $3 \times 2 \times 31 \times 2 = 372m^3 @ \text{Rs.}40/m^3 = \text{Rs.}14,880$
- ii) Plastic(500μ) =  $(31+3) \times 2 \times 2 + (3 \times 31) \times 2 + (31+3) \times 2 \times 0.6 = 244.8m^2 \approx 250m^2 @ \text{Rs.}100/m^2 = \text{Rs.}25,000$
- iii) Polythene =  $(3 \times 21 \times 2) \times 1.1 = 126 \approx 135m^2 @ \text{Rs.}10/m^2 = \text{Rs.}1,350$
- iv) Bamboo stick net = Rs.1,500
- v) Misc = Rs.270

Volume of water/*Jallergola* =  $3 \times 2 \times 31 = 186\text{m}^3$

Volume of water in 2 numbers of *Jallergola* =  $186 \times 2 = 372\text{m}^3 > 363\text{m}^3$
